**WENDEL/BUDC**

**Golf Course Feasibility Study**

**Phase I Environmental site Assessments  
Executive Summaries**

August 2013

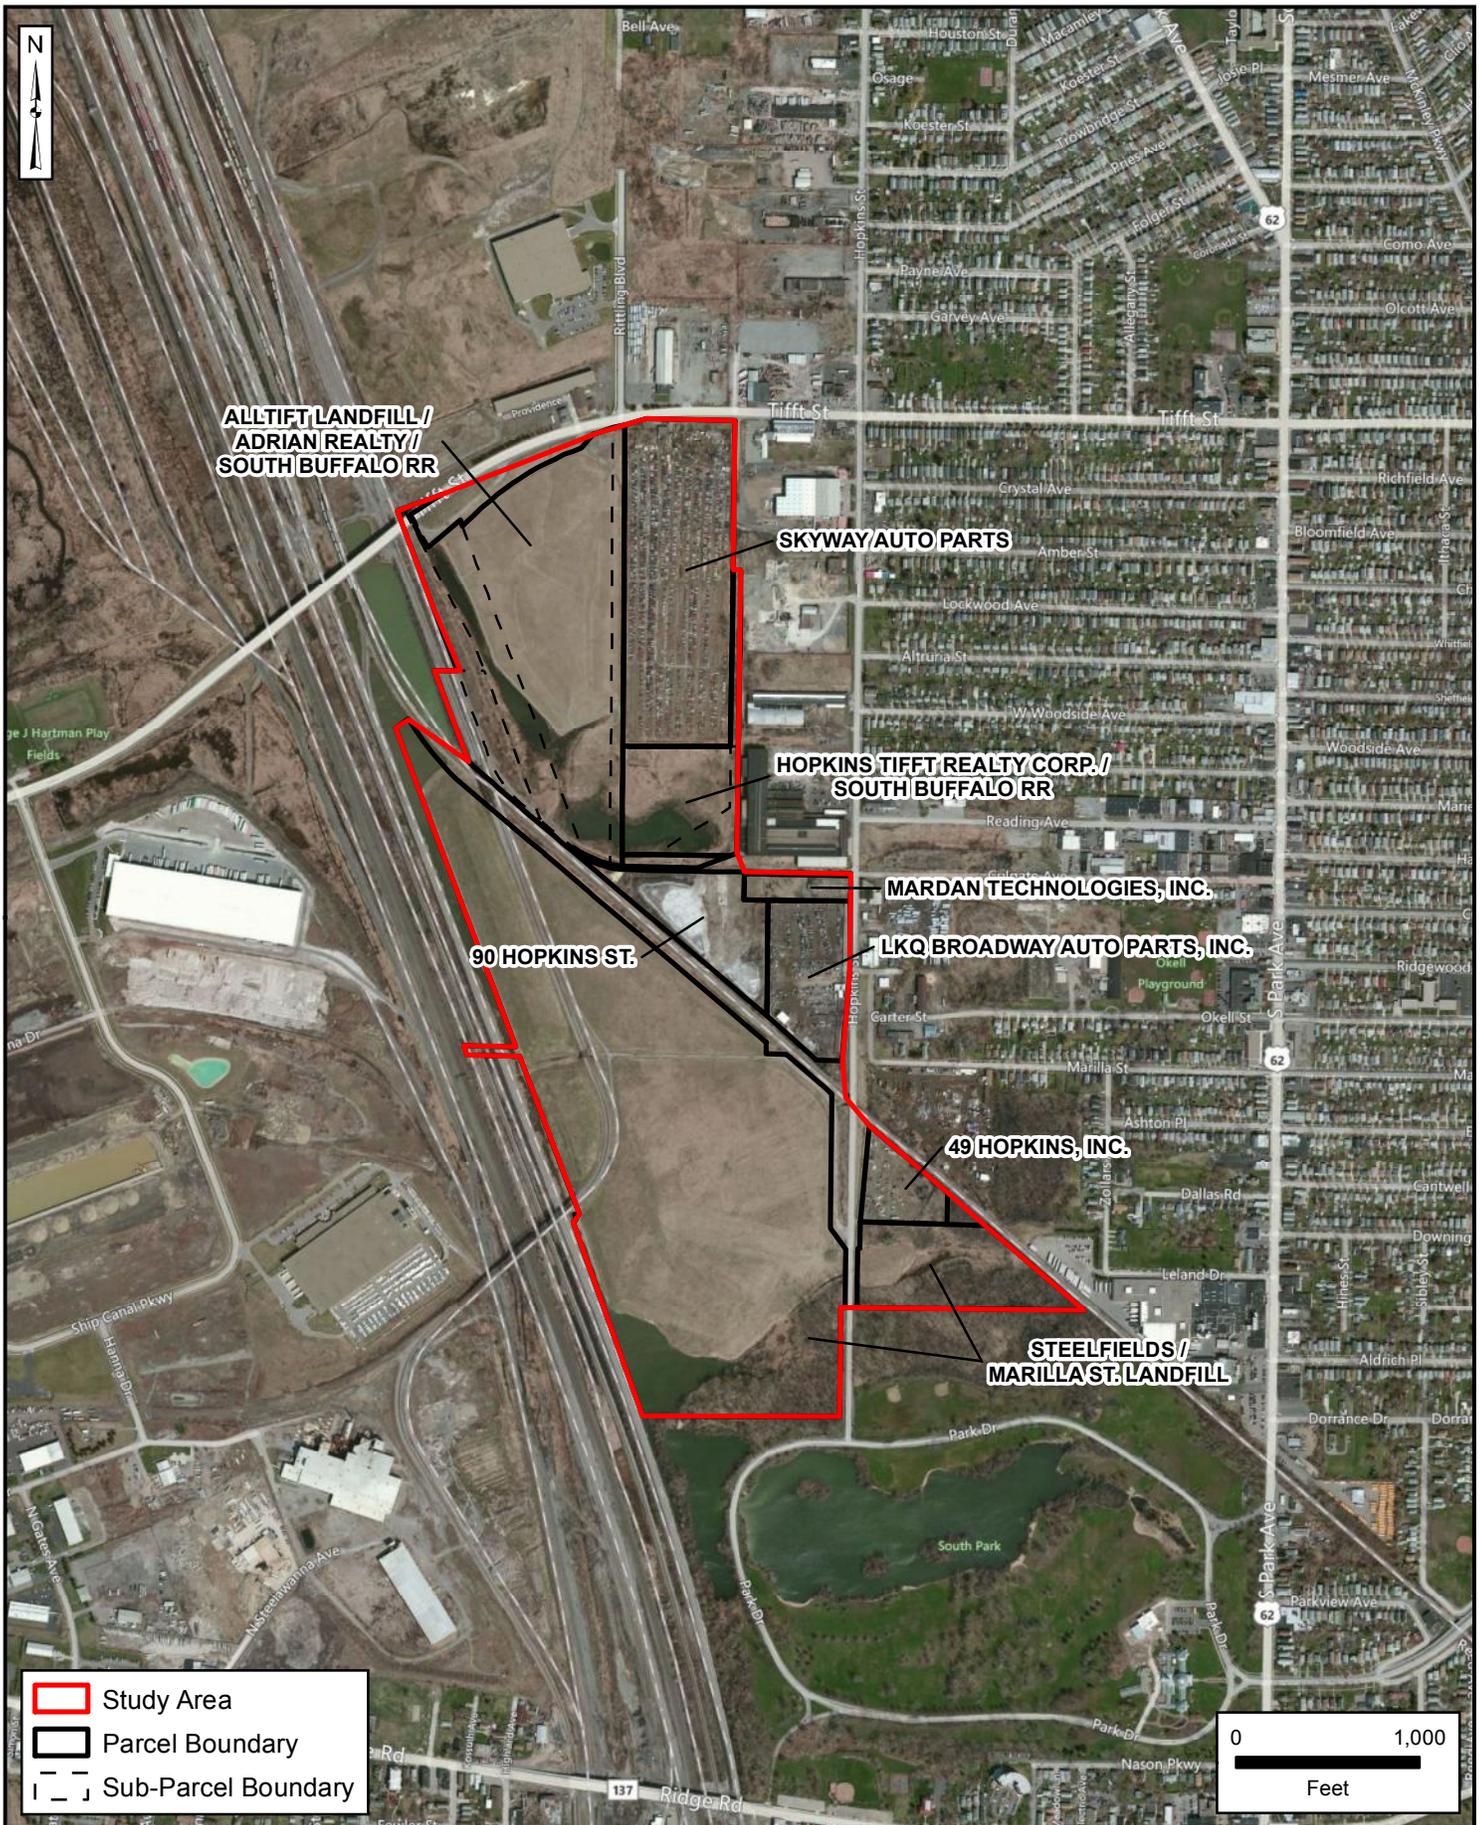
This report summarizes the findings of Phase I Environmental site Assessments (ESAs) completed for the South Buffalo Golf Course Feasibility Study, which includes the properties identified in Table 1 on the following page, and illustrated on Figure 1 - Study Area Parcels Map included as Attachment 1.
